Proceedings of the Public Workshop

“Beach protection: risk and management”

Yeppoon, 7 February 2002

| | Page |
|--|---|
| HARD/SOFT METHODS OF BEACH PROTECTION. THE CAPRICORN COAST CASE STUDY. Jurek Piorewicz, CQU | |

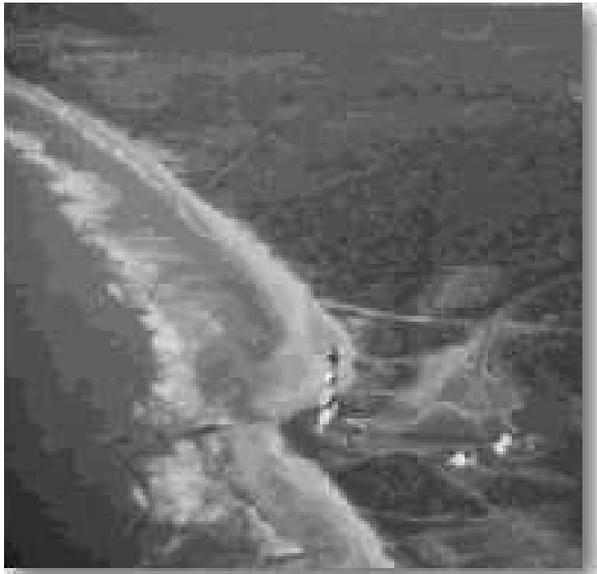
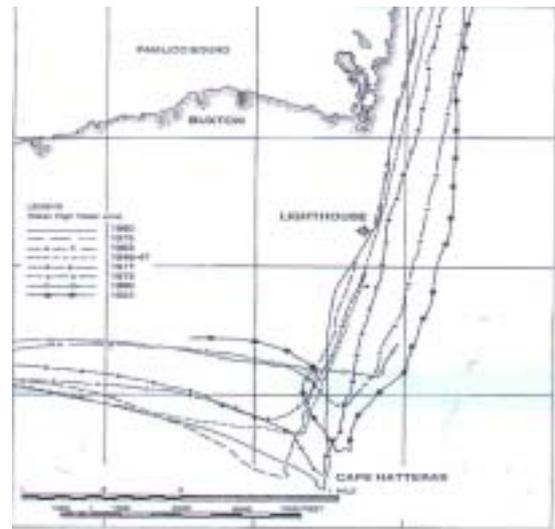
FIGURE 7. Position of the shoreline at Cape Hatteras 1852-1980. SOURCE: U.S. Army Corps of Engineers, 1983.

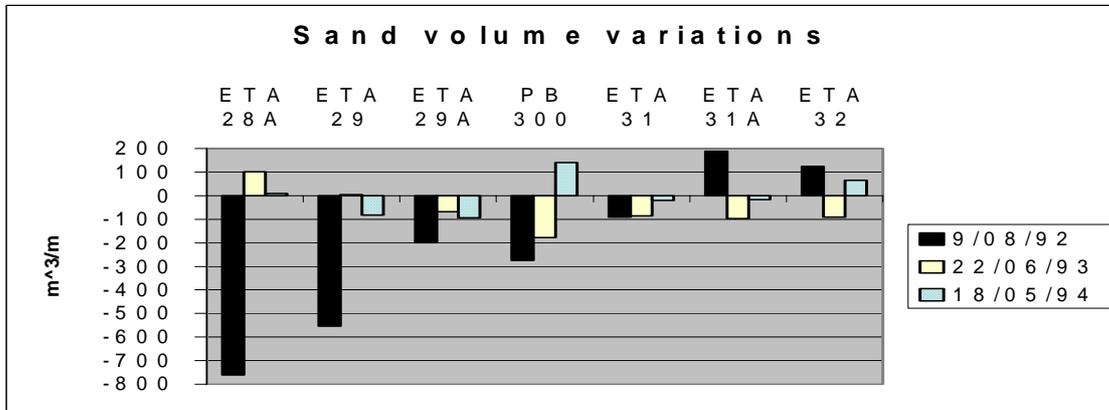
Figure 7 - Sand Volume along Palm Beach

The accretion of the berm is faster when the seabed is stable and is not required to build up a storm bar. The most part of the temporary erosion of Palm Beach is due to the onshore-offshore sand redistribution. The active prism plays a role in the wave energy absorption and the visible beach is just a minor compartment of the total profile. However, natural exchange with the dune and the underwater profile represents a non-negligible amount of sand:

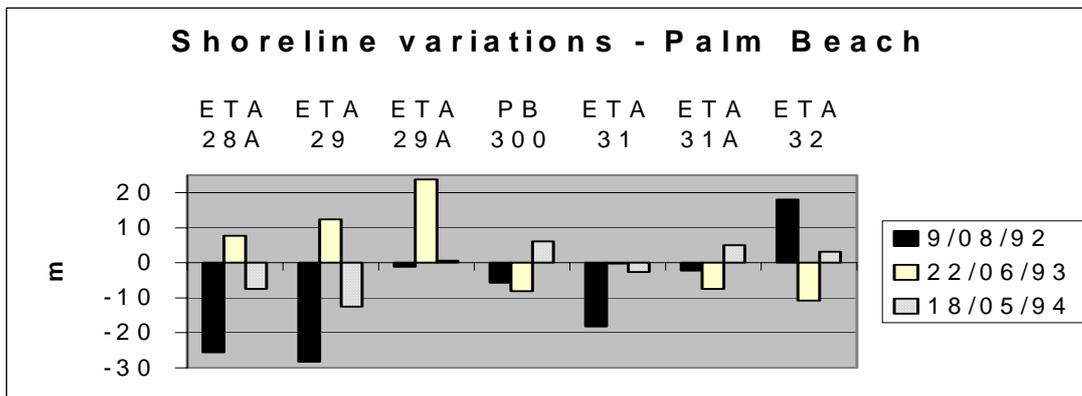
Figure 8 – Beach Width along Palm Beach

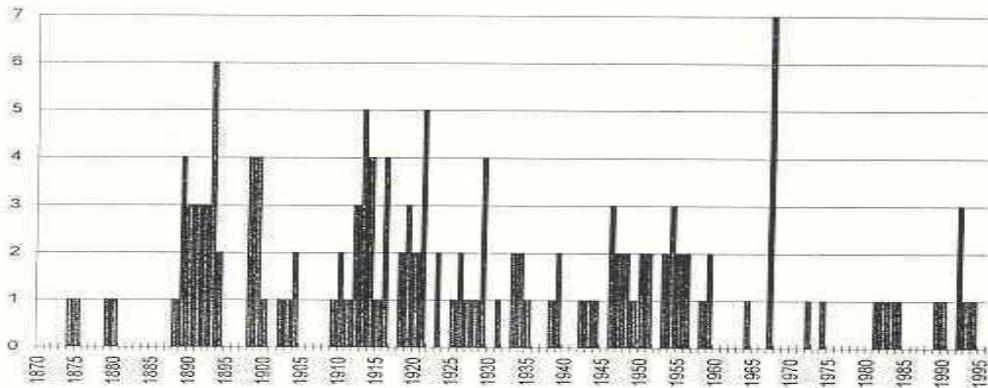
Figure 9 – Cyclone Occurrence – Gold Coast

At the extreme end of the scale of natural variability is the impact of a cyclone or major storm. The majority of our cyclones impact on the coastline in north Queensland. But occasionally they track down the coast bringing with them very high waves and wind conditions. The occurrence of these events on the Gold Coast is shown in Figure 9.

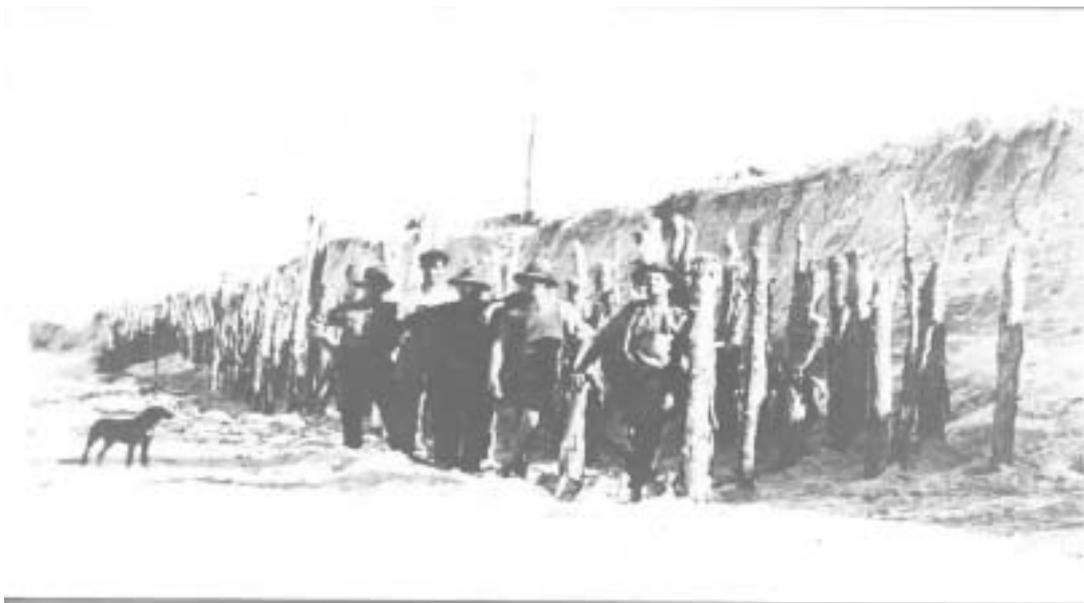
Figure 10 – Beach Protection at Narrowneck 1936

Figure 10 shows a photograph taken in 1936 after the storms of that year exposed an old seawall believed to be constructed in the 1920s to protect Narrowneck. This wall was replaced in 1936 and was exposed again in recent years. This is a good example of the cut and recover cycle we see when major storms hit.

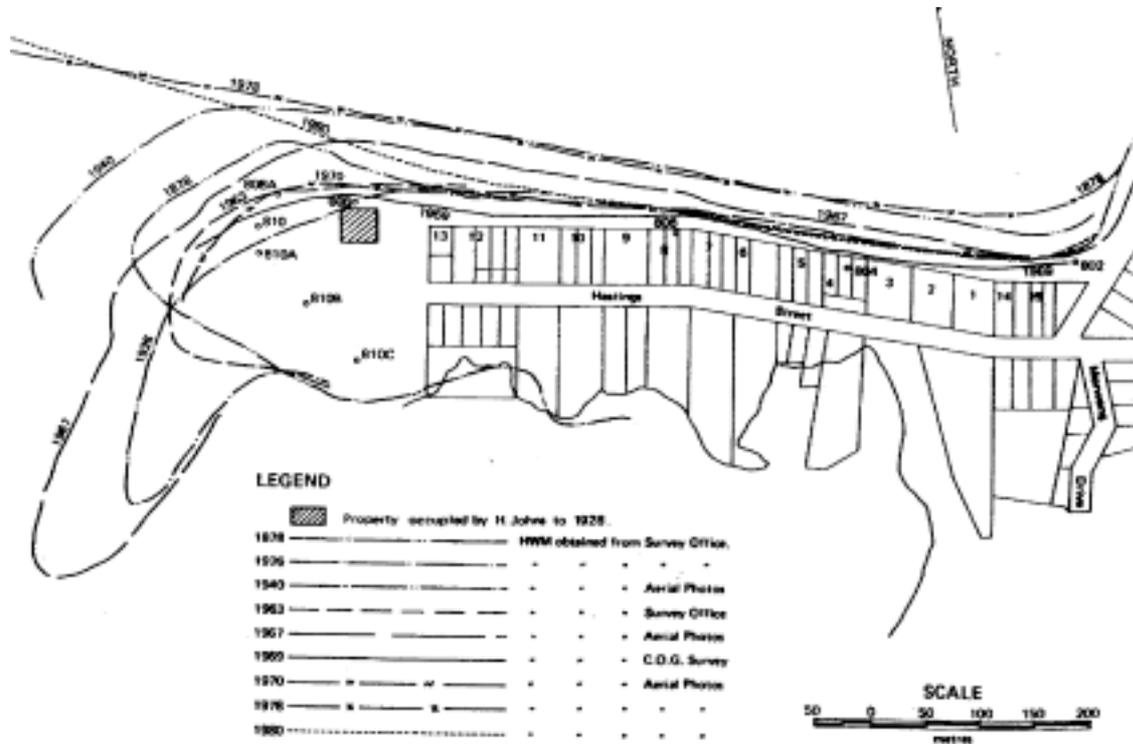
Figure 15 High Water Marks along Main Beach

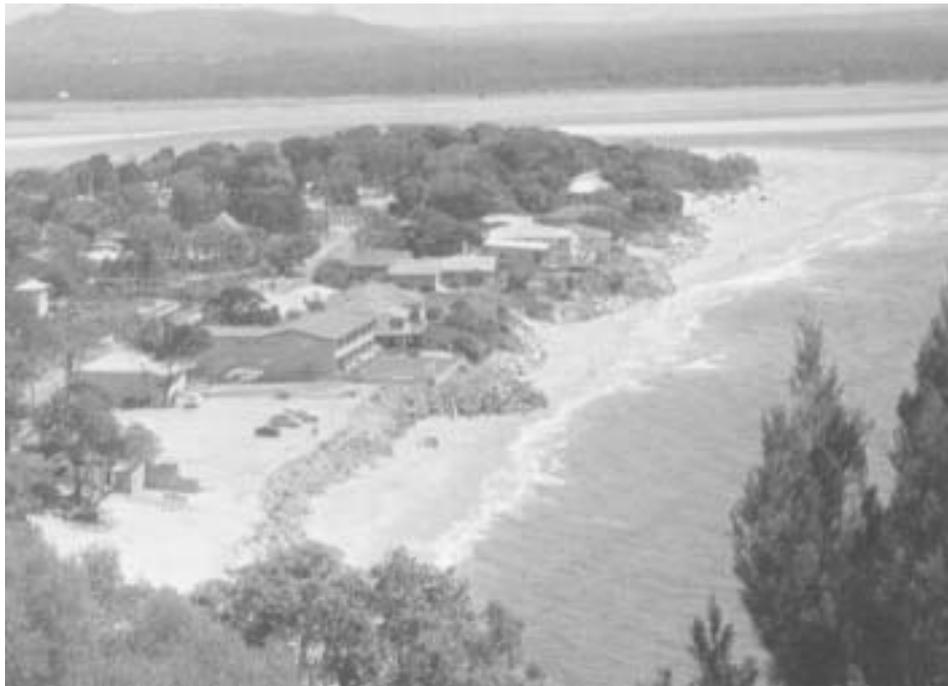
Figure 16 Individual Rock walls dumped by property owners in 1967 (Ref. Cato, 1979)

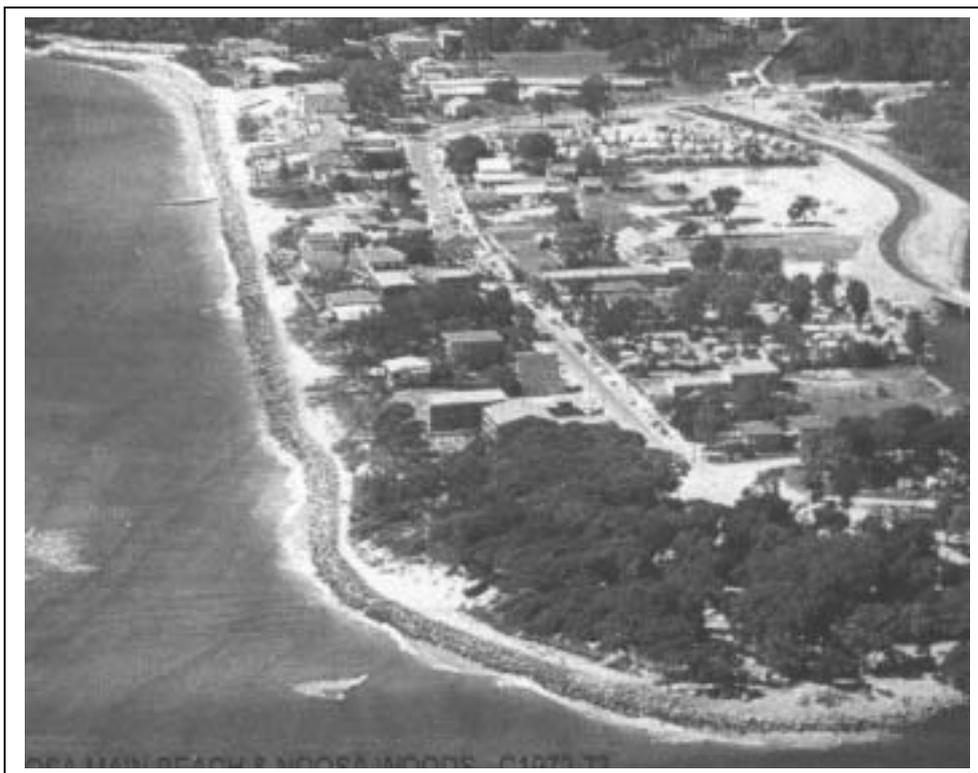
Figure 17 Rock wall along the foreshore in 1972-73 when the Noosa River estuary entrance was adjacent to Noosa Woods.

In order to manage the movement of the tidal entrance channels within the estuary, the entrance was relocated in 1978. The effect of the entrance training on the beach has been to translate the ebb-tidal delta to the west, away from Noosa Woods and Noosa Main Beach. This has eliminated the protective offshore delta of sand. However, this shift of the entrance is not solely responsible for the erosion of the Noosa Beach foreshore, as historical photographs show that coastal erosion was occurring along Noosa Beach when the entrance was adjacent to Noosa Woods (Figure 17).

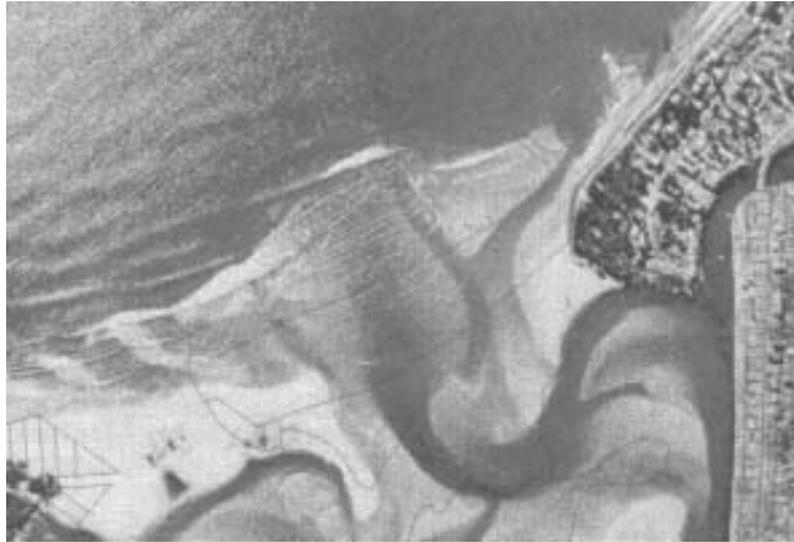
Figure 18 Entrance prior to relocation of river mouth - May 1978

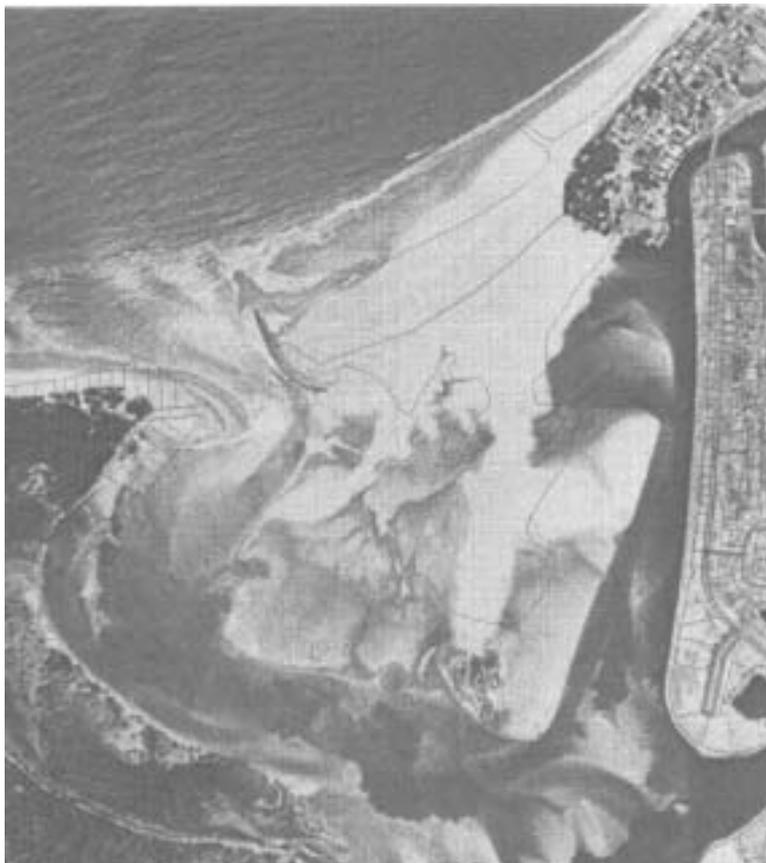
Figure 19 Entrance after relocation - October 1978

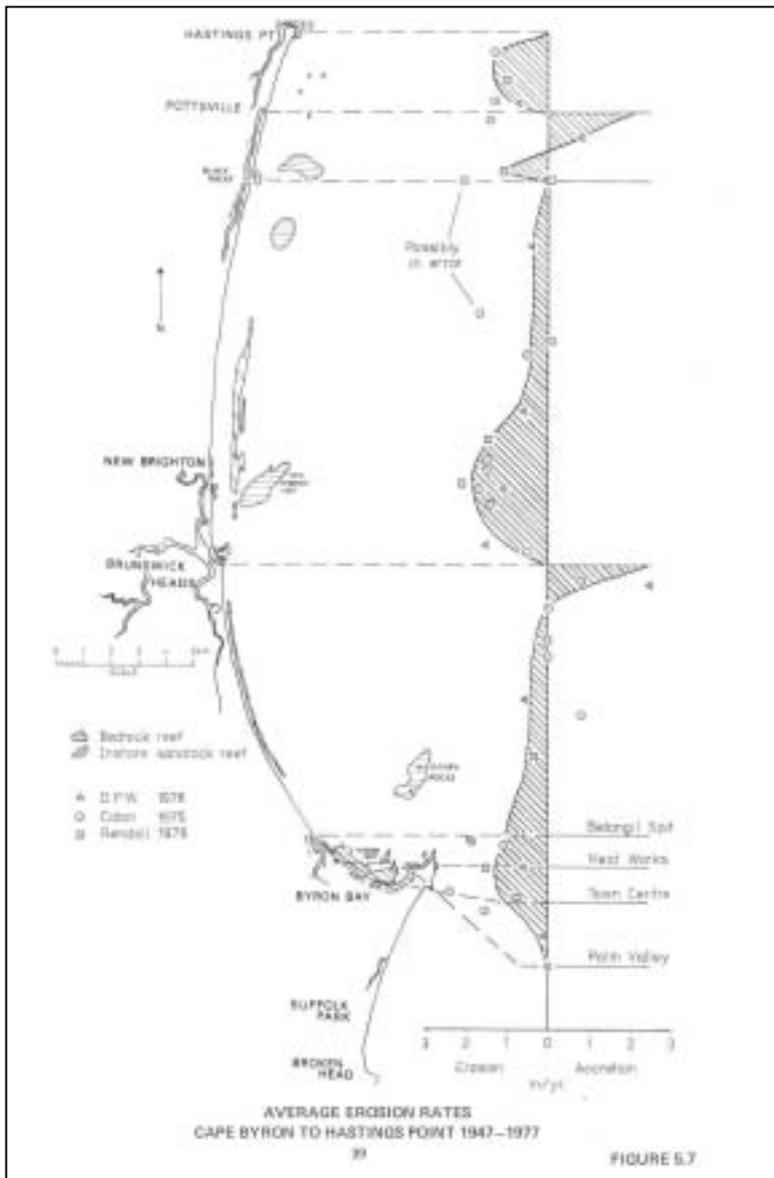
Figure 22 Bryon Bay Shoreline recession (Gordon et al 1978)

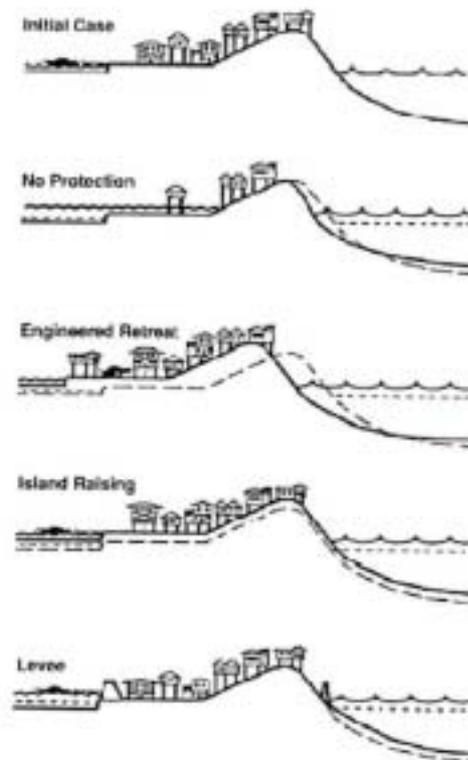
Figure 24 – Engineering Options for Long Term Management

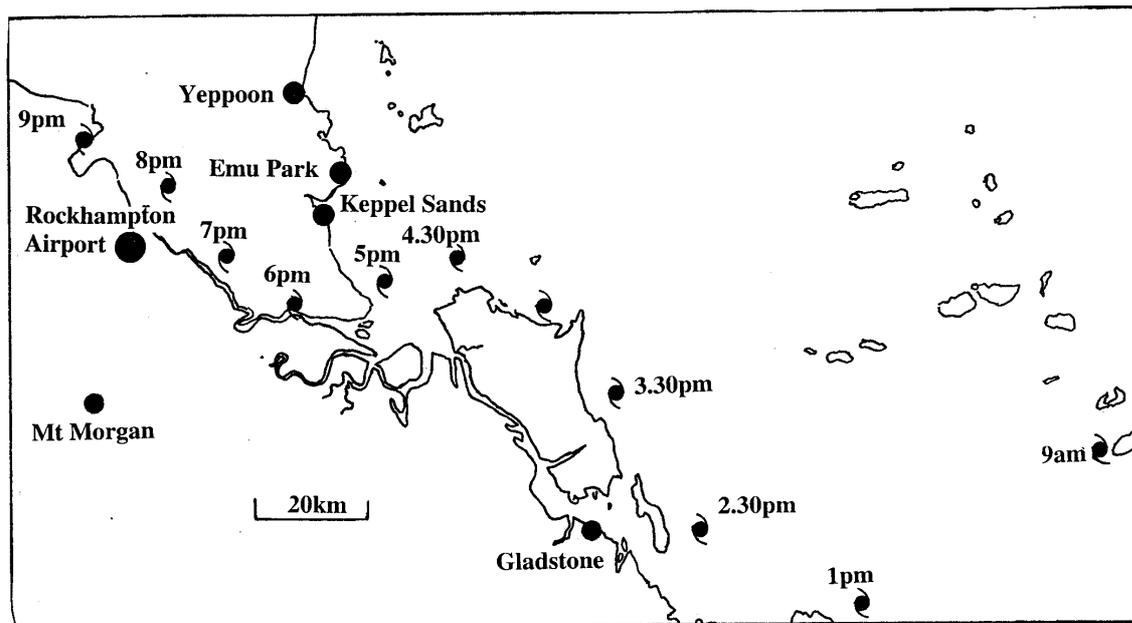
Figure 1. Track of the 1949 severe tropical cyclone From 9am 2 March 1949 to 9pm 2 March 1949.

Tropical cyclones are classified as severe if they reach at least the category 3 level of intensity. From Table 1 severe tropical cyclones are capable of inflicting major (category 3), devastating (category 4) or extreme (category 5) damage. A severe tropical cyclone, which probably fluctuated between category 4 and category 3 intensities, caused widespread damage over the region during March 1949. The track of the cyclone through the region has been constructed in Figure 1.

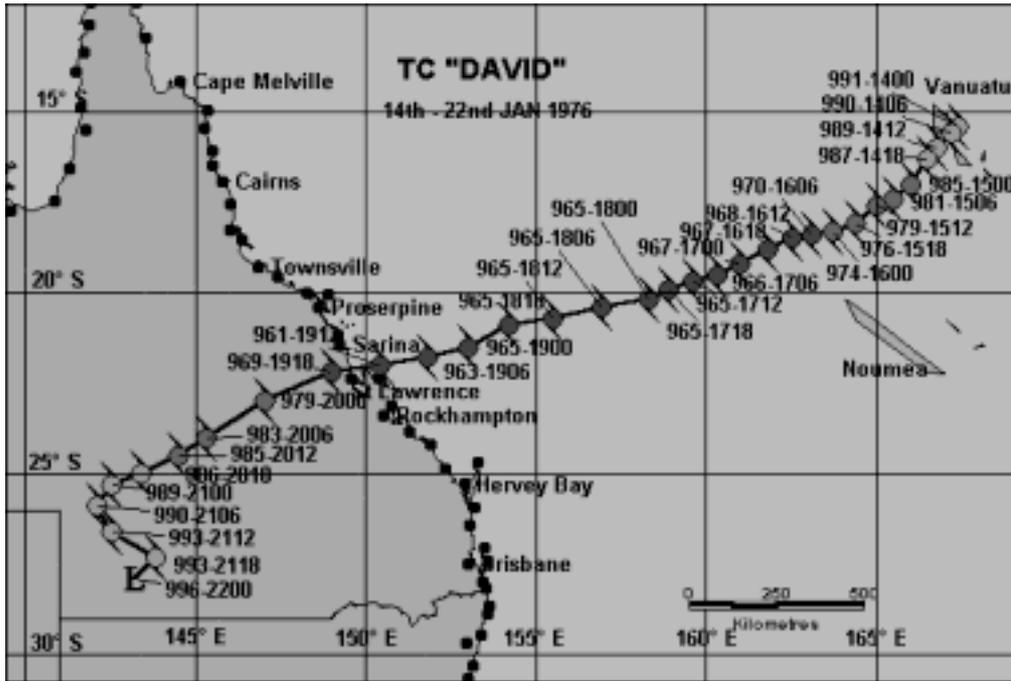
Figure 3. Track of tropical cyclone *David*. Numerical group ppp-ddhh with each cyclone position where ppp denotes the central pressure (hPa) and dd is the date (UTC) and hh is the hour (UTC). UTC is Australian EST – 10 hours.

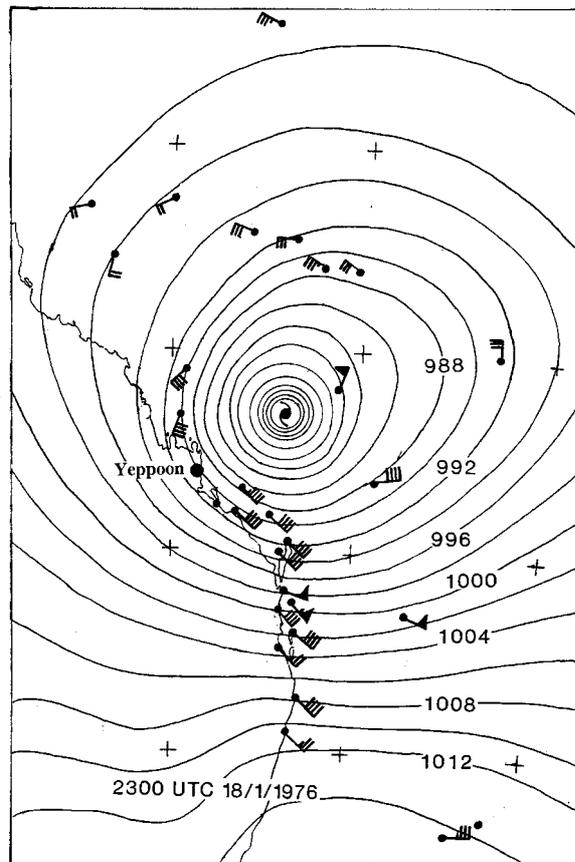
Figure 4. Tropical cyclone *David* at 9am 19 January 1976. Mean Sea Level Pressure distribution (hPa) together with selected wind observations. Flag represents 50 knots (25 m/s) full barb represents 10 knots (5m/s) and half barb represents 5 knots (2.5m/s).

Figure 4 shows the mean sea level weather chart for 9 am Monday 19 January 1976. The wind plots in Figure 4 indicate that there was a huge area of gales associated with *David* extending from Papua New Guinea waters down to areas off the northern NSW coast.

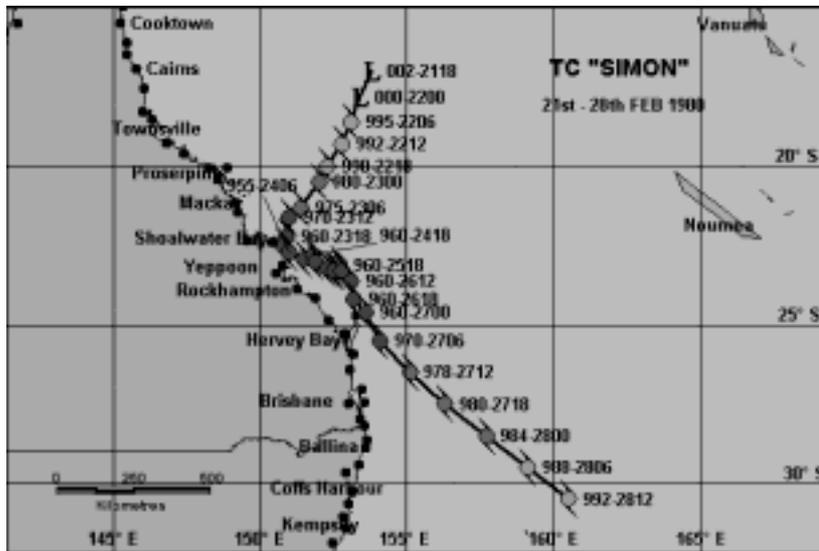
Figure 5. Track of tropical cyclone *Simon*.

In contrast tropical cyclone *Simon*, was a very intense small cyclone. The track is shown in Figure 5 and notice that *Simon* made landfall in the remote and sparsely populated area north of Yeppoon. Its small size can be seen in Figure 6. Though the peak winds near the centre would have been much stronger than *David*, the effect on Yeppoon was minimal with only tree damage even though it was much closer to Yeppoon than *David* was.

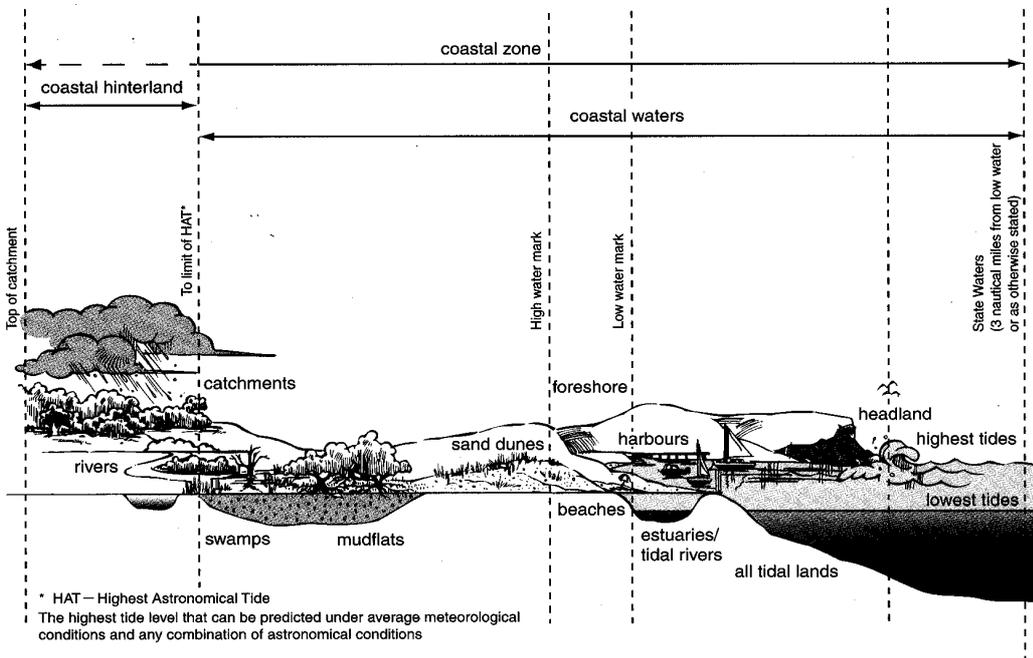
Figure 1. Coastal Zone

It applies to the coastal zone, defined in section 11 of the Coastal act as “Coastal waters and all areas to the landward side of coastal waters in which there are physical features, ecological or natural processes of human activities that affect, or potentially affect, the coast or coastal resources”. Schematically coastal zone is shown in Figure 1.

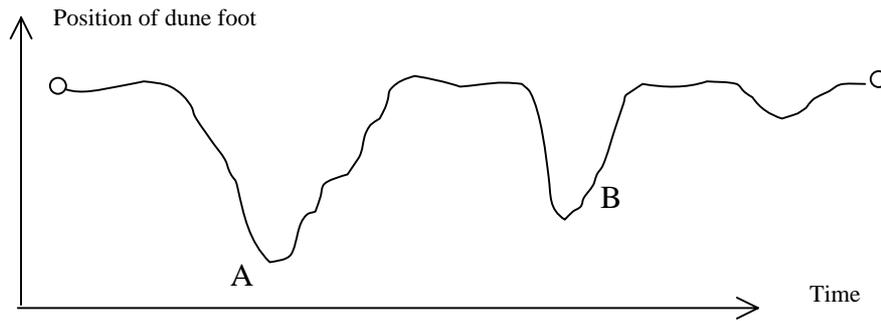
Figure 2. Position of the dune foot as a function of time

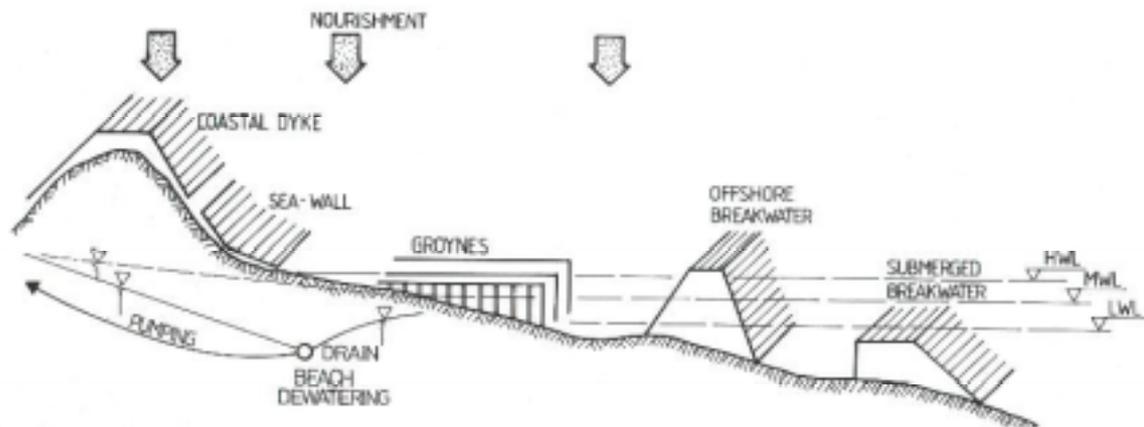
Figure 5. Different types of shore protection structures

The different coastal structures have different influence on reshaping of the coastline. Figure 5 presents schematically different types of the structures and their location on the coast.

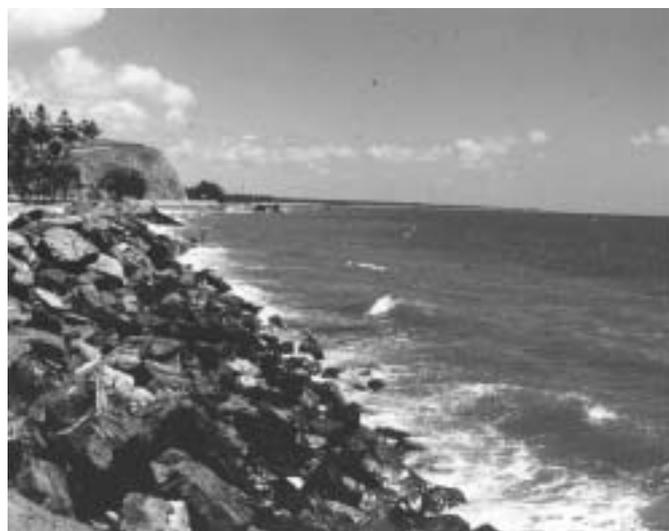
Figure 6. Bulkhead on Yeppoon Main Beach at High Water

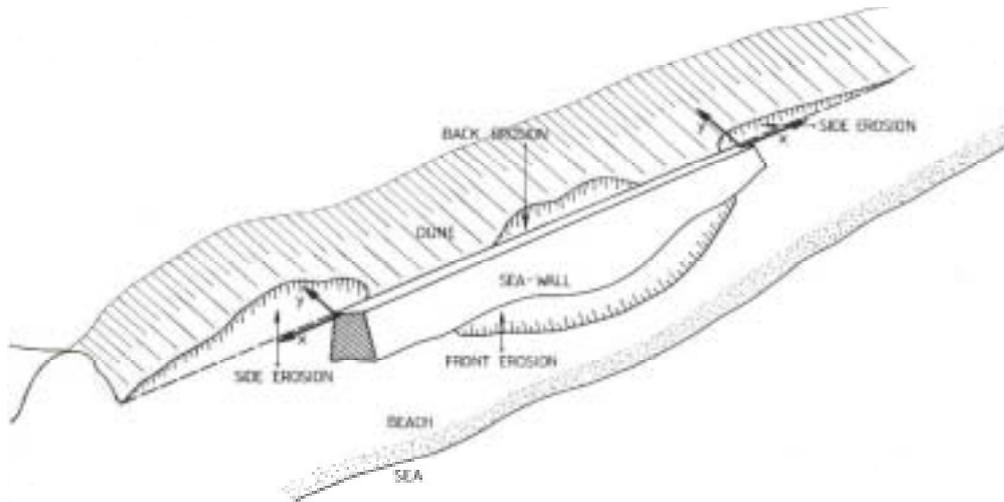
Figure 7. Possible local erosion around seawall

- erosion at the ends of the sea-wall due to superposition of the coming waves with waves reflected from the sea-wall,
- -erosion behind the sea-wall due to overtopping waves, and
- -erosion in front of the sea-wall due to strong wave currents caused by wave reflection.

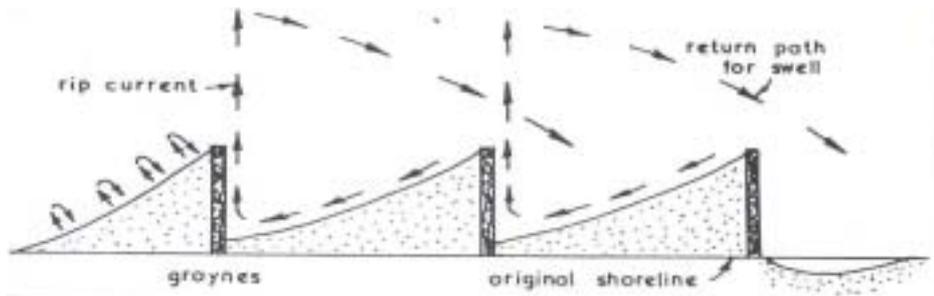
Figure 9. Shore-normal groynes

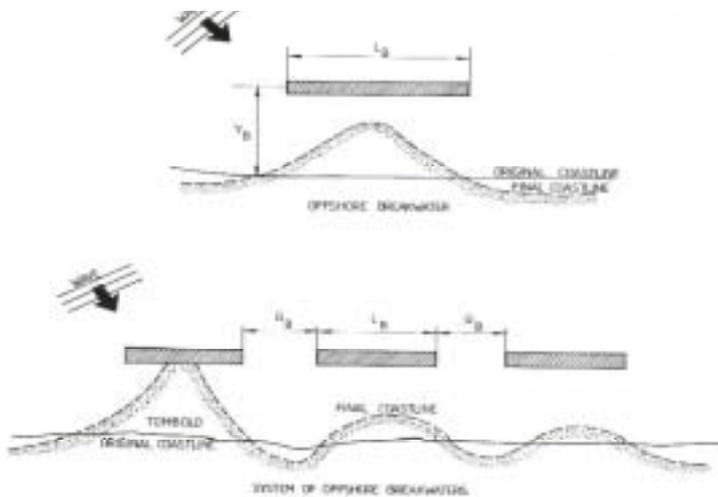
Figure 10. Principles of detached breakwaters

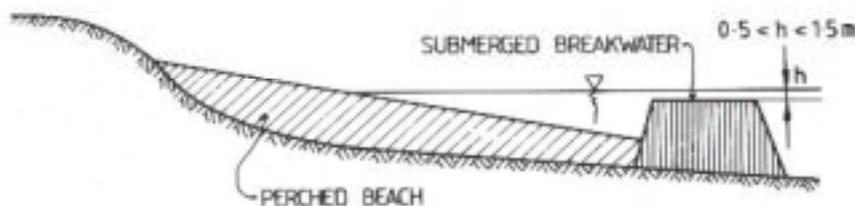
Figure 11. Submerged breakwater

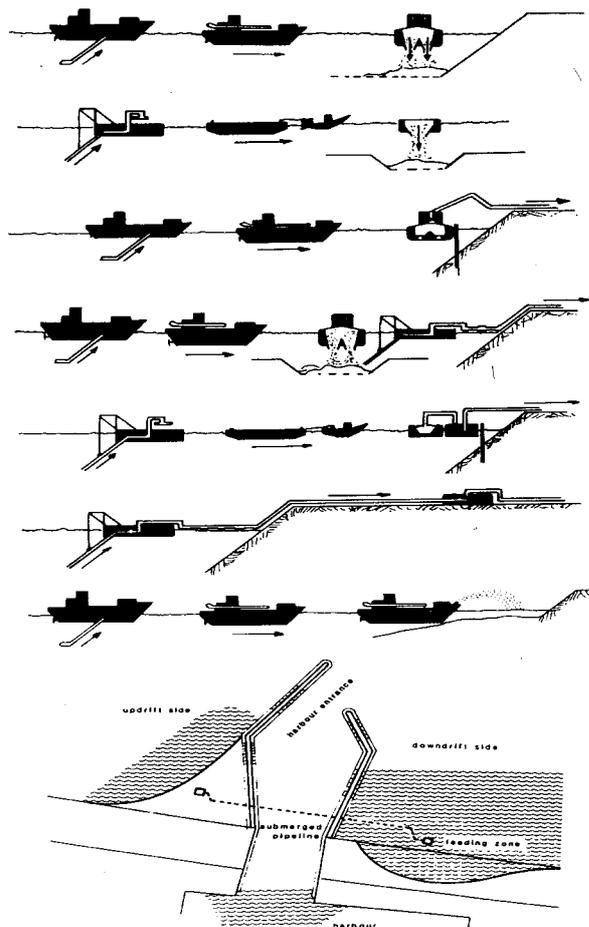
Figure 12. Different methods of beach nourishment (CUR Report 130)

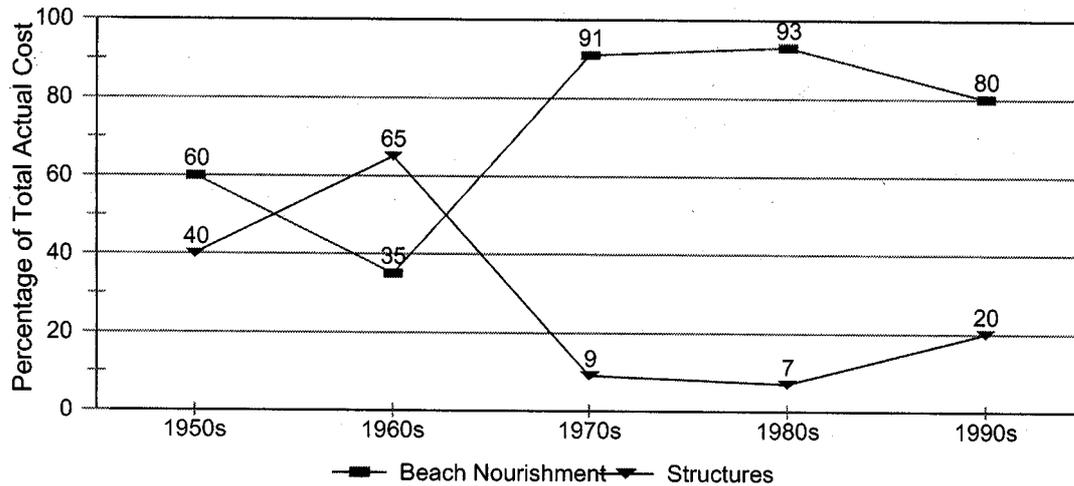
Figure 13. Implementation of beach nourishment in USA (CEM, 2001)

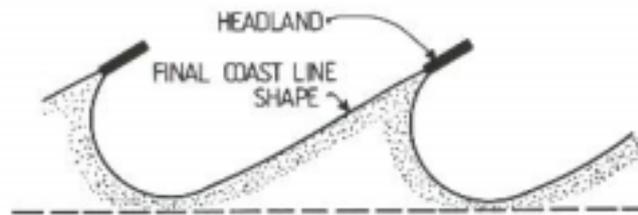
Figure 15. Headland control on straight beach

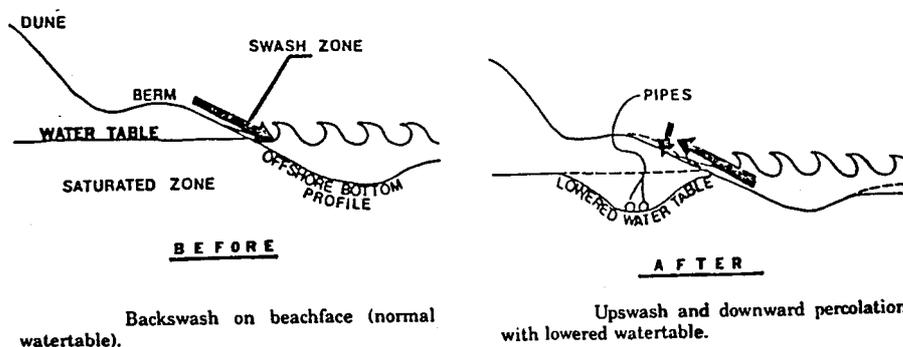
Figure 16. Principles of beach dewatering

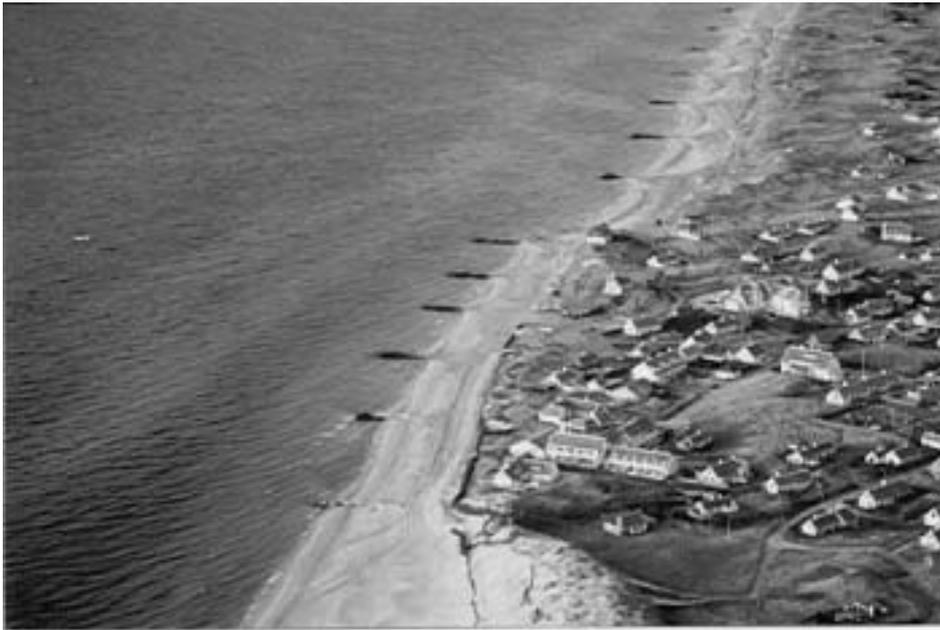
Figure 17. Aerial photo of the groynes at G1. Skagen, before the implementation of pressure equalisation modules. (www.skagen-innovation.dk)

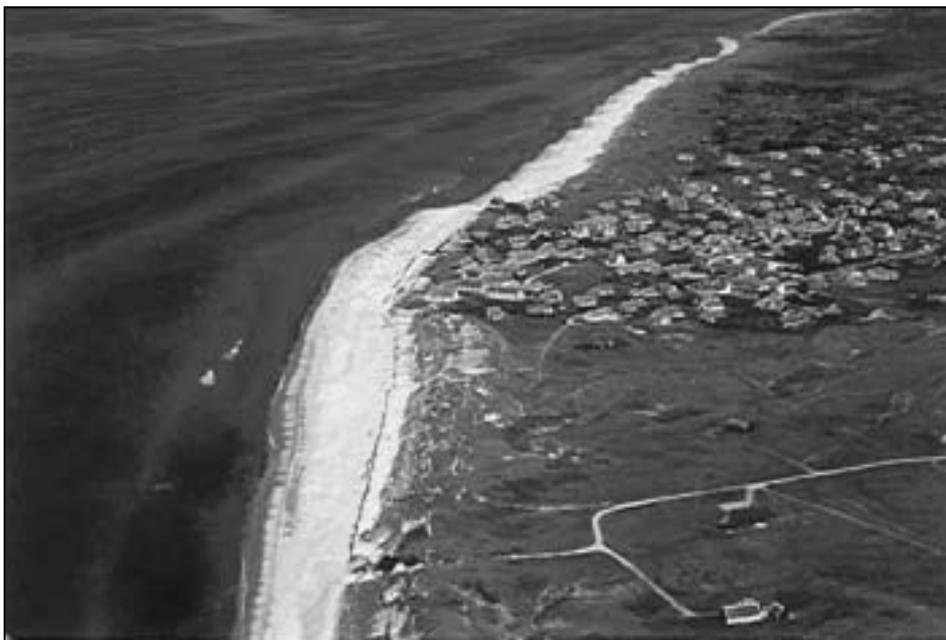
Figure 18. Aerial photo of the same location in 1999, 15 months after the implementation of pressure equalisation modules. (www.skagen-innovation.dk)

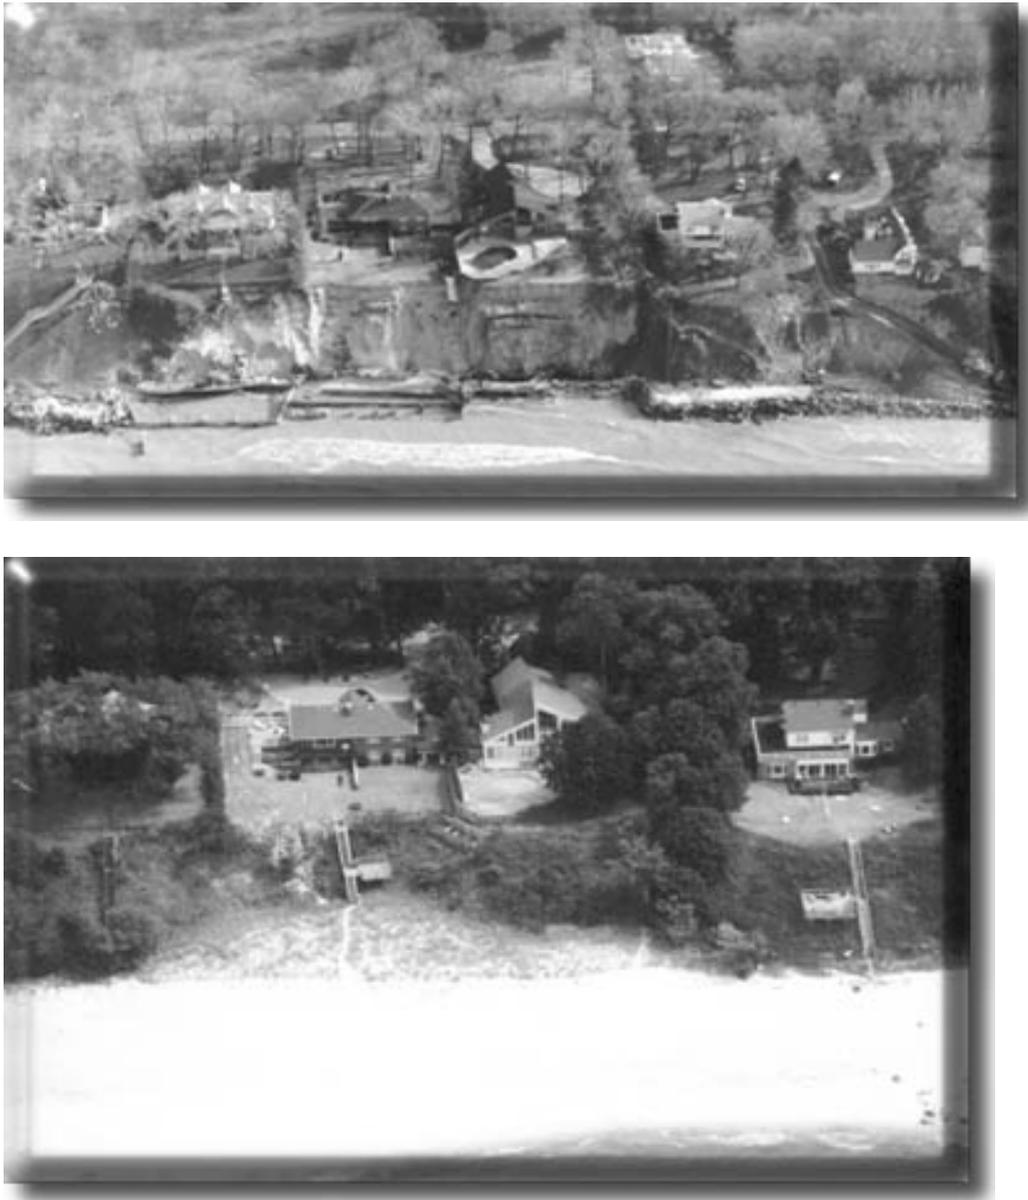
Figure 19. Example of undercurrent stabilizers application. (www.erosion.com/shore.html).

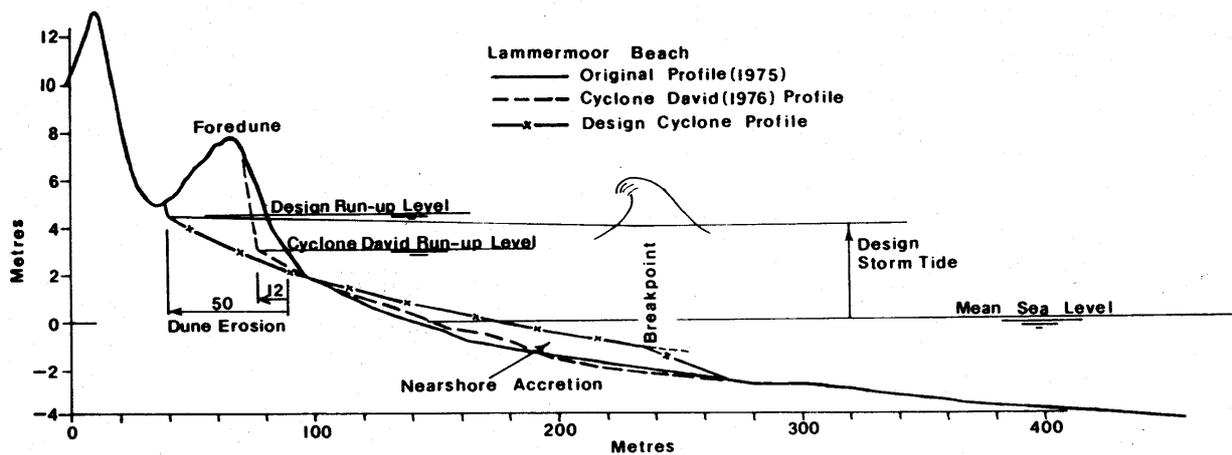
Figure 21. Cyclone dune erosion for Lammermore beach (BPA, 1979)

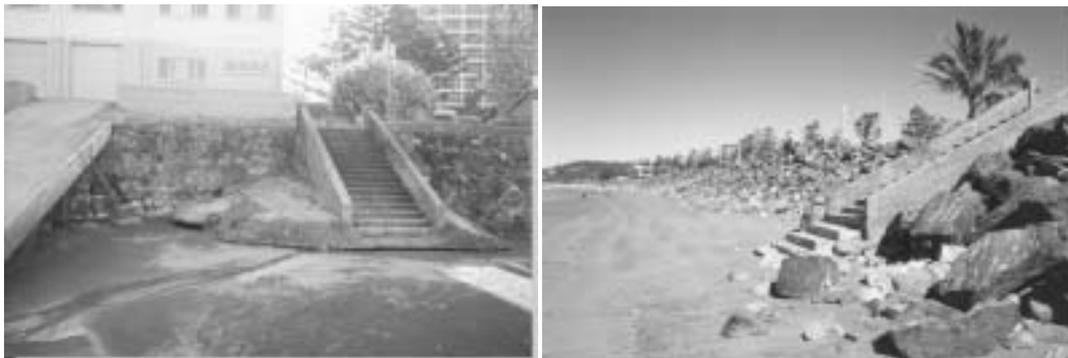
Figure 25. Erosion of the Yeppoon Main Beach, situation in early 1990's.

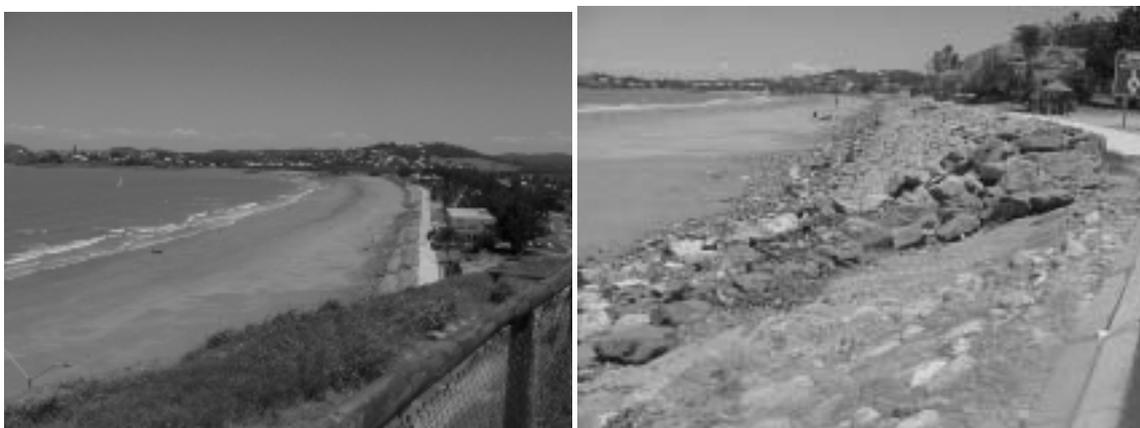
Figure 26. Reconstructed rockwall on Yeppoon Main Beach, situation in January 2002

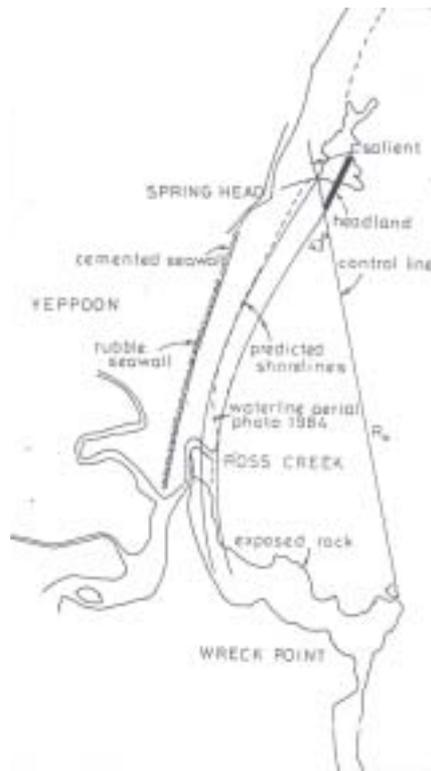
Figure 27. Considered headland to restore Yeppoon Main Beach

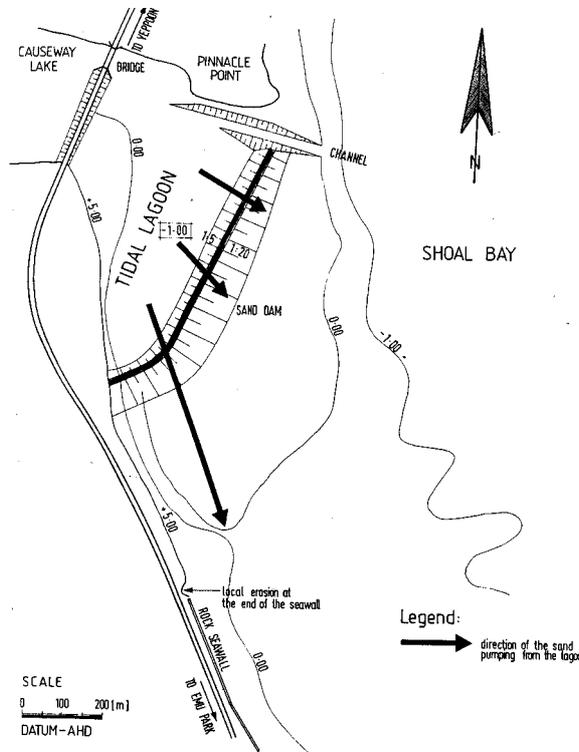
Figure 34. Implemented solution to restore north part of Kinka Beach

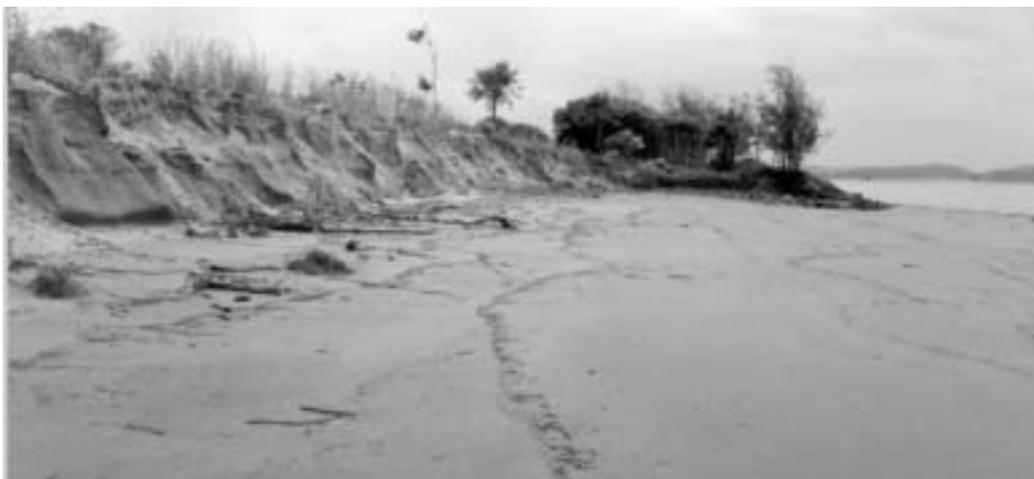
Figure 37. Erosion on south end of Kinka beach, March 1996

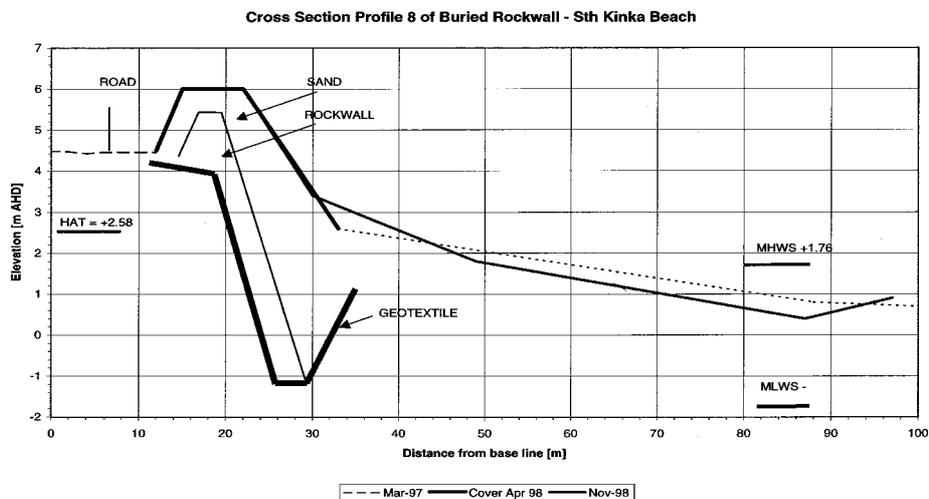
Figure 38. Buried seawall cross-section

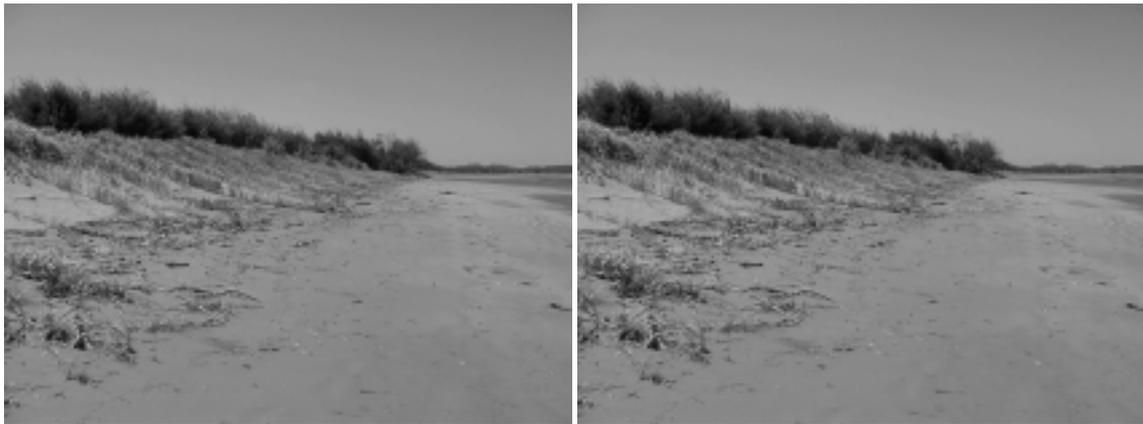
Figure 39. Buried seawall April 1998 and January 2002

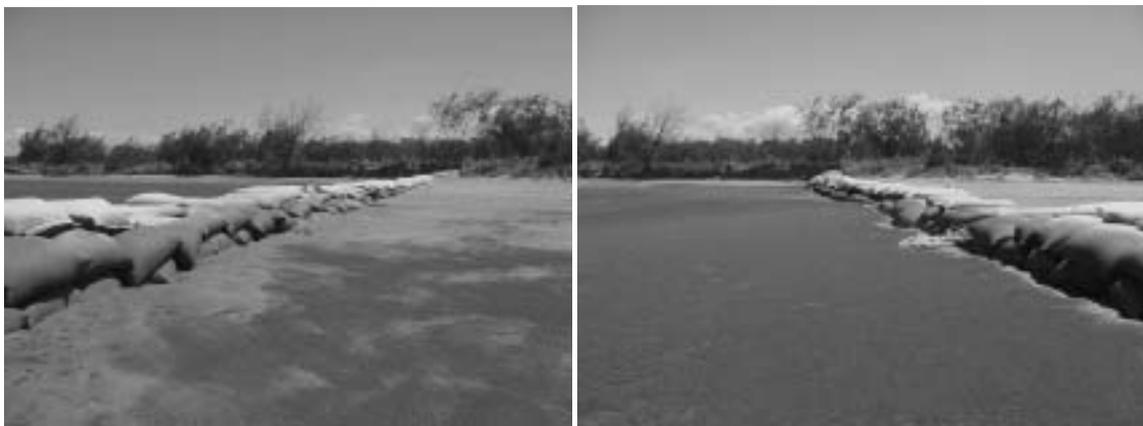
Figure 40. Geo-textile groyne on South Kinka, January 2002
