Proceedings of the Public Workshop

“Beach protection: risk and management”

Yeppoon, 7 February 2002

| | Page |
|--|---|
| HARD/SOFT METHODS OF BEACH PROTECTION. THE CAPRICORN COAST CASE STUDY. Jurek Piorewicz, CQU | |

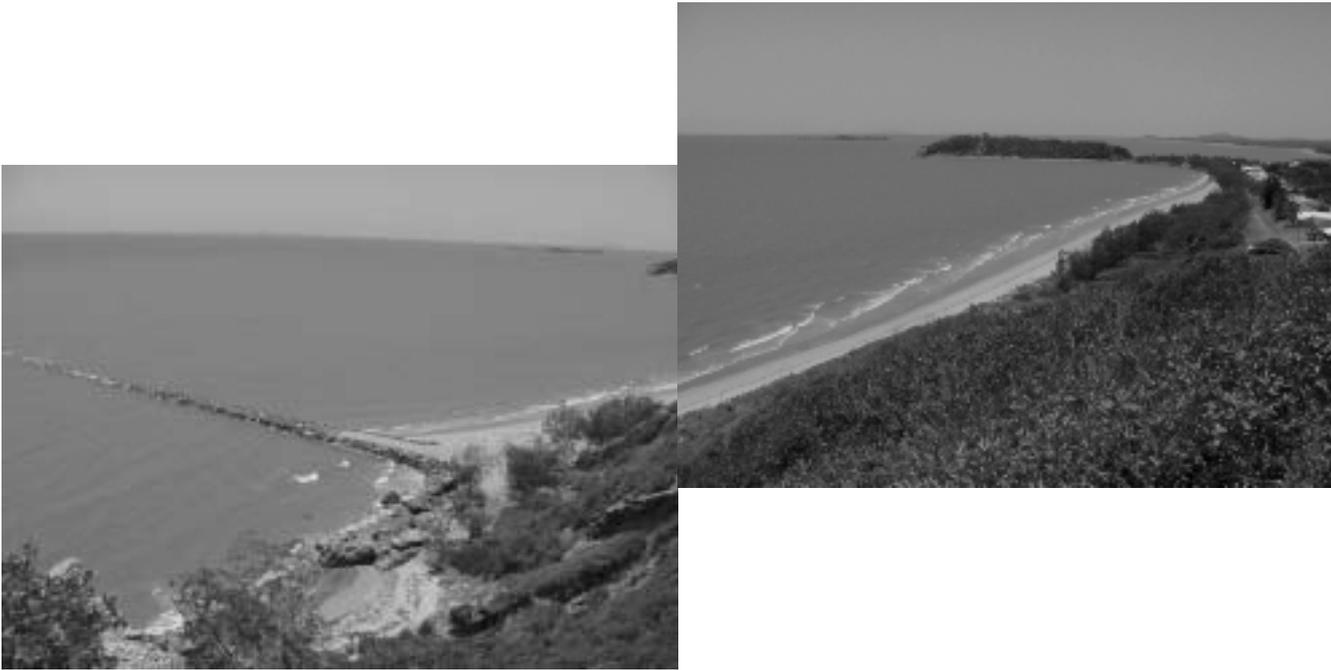
Figure 44. Extended groyne on Keppel Sands Beach, January 2002
